Repair of the inner steel shell of an underground liquid fuel tank with a polyester-glass laminate

DOI: 10.15199/33.2024.04.02

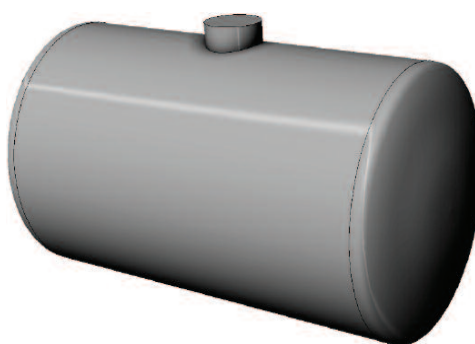
Photo 2. The analysed underground tank
Fot. 2. Analizowany zbiornik podziemny

The analysis was conducted for the double-wall underground tank for storing flammable liquid materials, with a nominal capacity of 20 m³ and an (inside) diameter

of the inner shell of 2500 mm. A wall thickness of the inner and outer shell were 6 and 4 mm respectively. Both shells were made of carbon steel S235JR. The constant distance between the shells was provided with circumferential distribution bars with a diameter of 4 mm, at the spacing of approx. 1500 mm over a length of the cylindrical part of the tank. The load, the source of which was inside the tank, was assumed to be transferred only through the inner shell. Therefore, the model for numerical analysis included only the inner shell and the fill pipe with the cover. The shell was under the self weight and subjected to inside (excess)

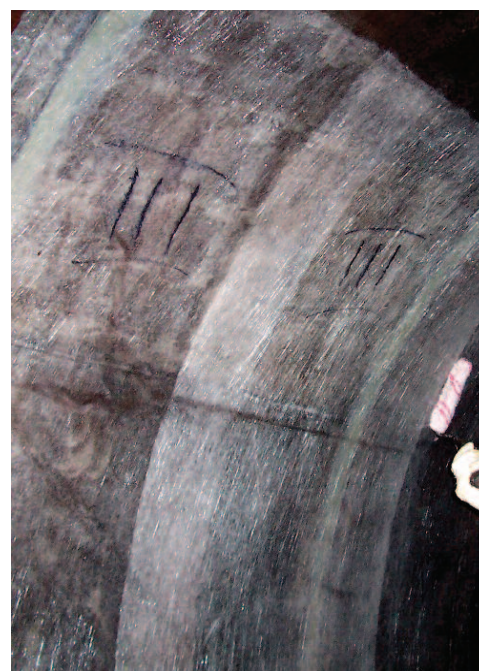
Photo 3. Applying a polyester-glass laminate to the inner surface of the tank shell
Fot. 3. Nakładanie laminatu poliestrowo-szklanego na wewnętrzną powierzchnię płaszczu zbiornika

The discussed method of repair is classified into the so called **laminating techniques** characterized by laminate coats easily formed on the large area of cylindrical steel elements. The repair layer is usually applied over the whole surface of the inner shell of the tank. This repair method can be considered as an alternative for methods using special pastes, which are only used to repair the shell locally, where major corrosion losses are observed [5]. The laminate is composed of one or more layers of glass fabric in the resin matrix. The layers are applied to the inner surface of the shell, previously treated with the blast cleaning method. The first layer applied to the steel surface is a resin layer, which levels the surface (as there are some losses), primes it, and also protects against

corrosion. Fibreglass layers soaked with polyester resin with hardener are manually placed on the first layer. Then, the layers are pressed with a roller to uniformly distribute resin on the surface of fibreglass (Photo 3). The fibreglass layer is intended to improve the shell strength, mainly because of tensile stresses in the meridional and circumferential direction. Finally, the laminate is coated with electrostatic dissipative paint.

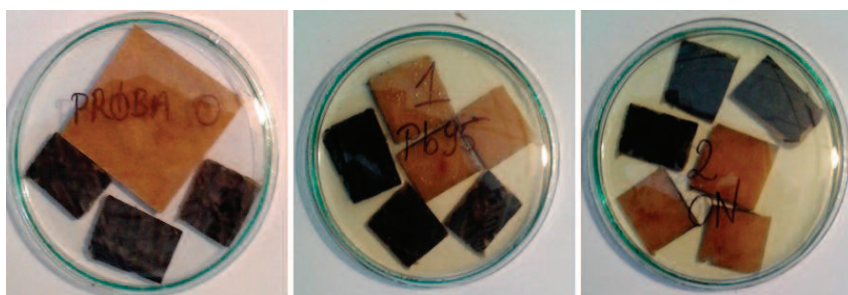
Photo 4. Laminate samples for testing
Fot. 4. Próbkki laminatu do badań

The tests covered **laminates made of glass fabric soaked with polyester resin**. The laminate tested was prepared in the laboratory conditions following precise principles of the manufacturing technology. Laminate samples were prepared using unsaturated polyester resin AROPOL M105 TB with a low emission of styrene, and the glass fabric EM 1002 with a weight of 150 and 225 g/m², joined with binder. The samples were subjected to ageing for six months without contact with fuel, and in the presence of Pb95 fuel and fuel oil ON (Photo 4).
